[BMW F10 535i xDrive Sedan](#) / [Repair Manuals and Technical Data](#) / [51 Body equipment](#) / [51 45 Trim, instrument trim panel](#) /

## 51 16 163 Removing and installing/replacing rear centre console cover

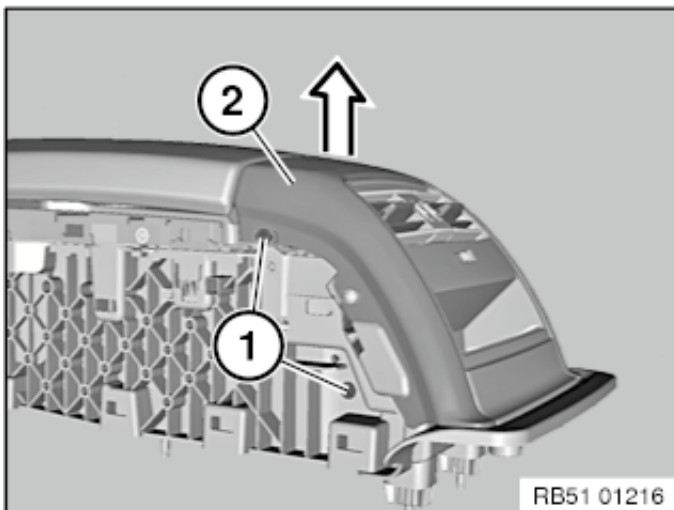
Open centre armrests.

Release screws (1).

Disengage rear centre console cover (2) in direction of arrow.

If necessary, unlock plug connections and disconnect.

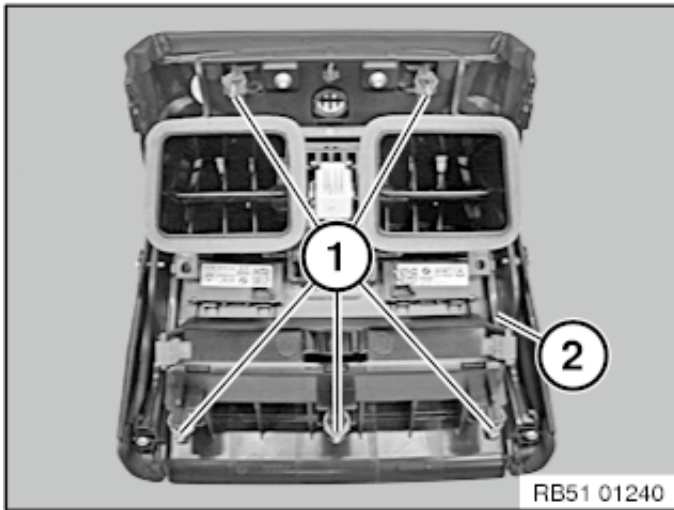
***Installation note:***

Retaining clips (1) of rear centre console cover (2) must not be damaged or missing.
