REP-REP-RAF1051-5141000 REP-REP-RAF1051-5141000 - Removing and installing left or right front door trim panel - V.5,

51 41 000

Removing and installing left or right front door trim panel

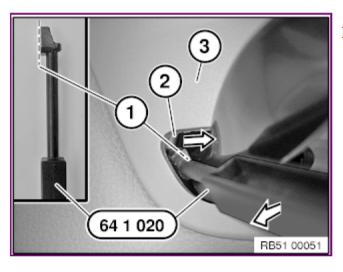
Pull out inside door handle (1) and hold open so that catch (3) on handle recess (2) can be released (see next operation).

At the same time, lift up handle recess (3) slightly at rear so that it doesn't snap back in again.
