[BMW F10 535i xDrive Sedan](#) / [Repair Manuals and Technical Data](#) / [51 Body equipment](#) / [51 45 Trim, instrument trim panel](#) /

62 30 005 Removing and installing/replacing trim for Head-Up Display

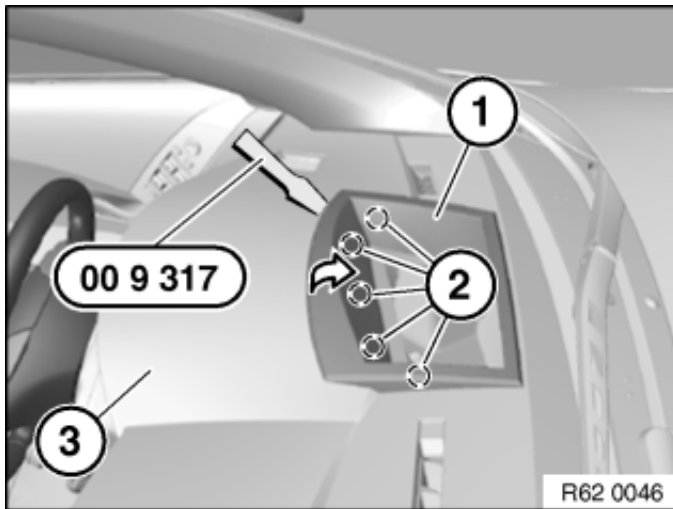
Lever out trim for Head-Up Display (1) with special tool [00 9 317](#) at mounting points (2).

Feed cover for head-up display (1) in direction of arrow out of instrument panel trim (3) and remove.

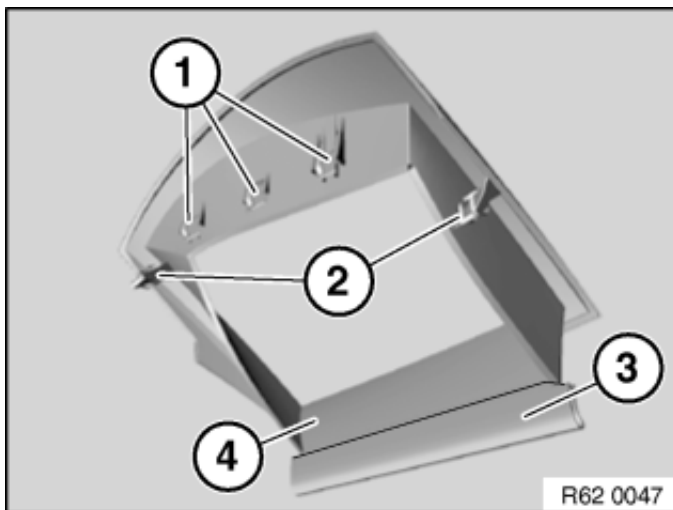
Installation note:

Make sure retaining lugs (1) and (2) and sleeve (3) of cover for Head-Up Display (4) are correctly seated.

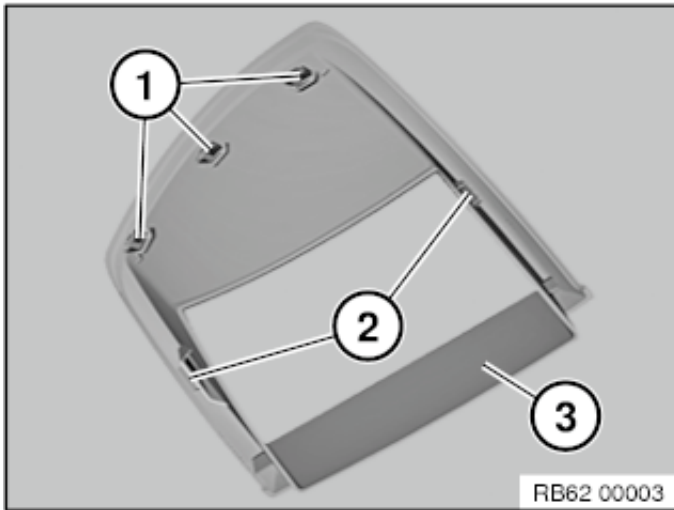
Only on F06, F12, F13:

Installation note:

Make sure retaining lugs (1) and (2) are correctly seated on cover for Head-Up Display (3).
